SealXpert Products

Leak Repair Application Note 24

Pipe Material: Carbon Steel Pipe
Pipe Medium: Natural Gas
Pipe Size: 4"
Pipe Pressure: 250 psig
Temperature: 30°C
Leak Location: Crack on pipe elbow and valves

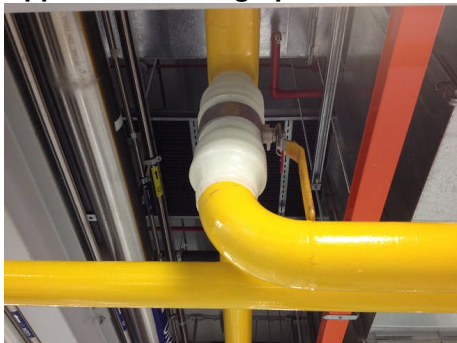
In a semiconductor plant, a 4" natural gas pipeline is leaking at the pipe elbow and valve connections. It is necessary to stop the leak as soon as possible without performing hot works and while the plant is in operation.

Pipe thinning and crack on pipe elbow

SealXpert™ repair putty and Seal Stic™ epoxy was applied onto the pipe elbow to stop the leak and reinforce the pipeline. Next, Wrap Seal™ fiberglass tape was applied over the repaired surface to increase the pipe wall thickness.

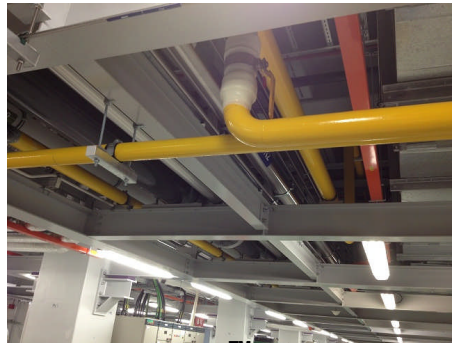
Applying SealXpert™ repair putty

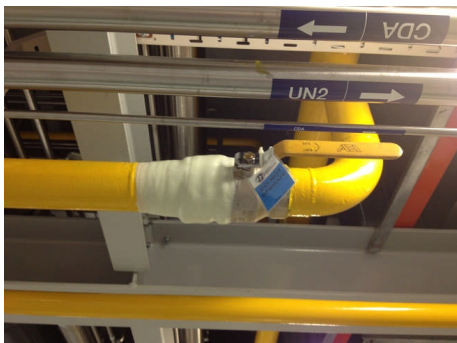
Applying SealXpert™ repair putty

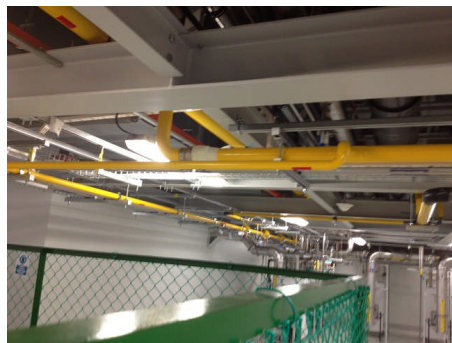
Repair and reinforcement works completed
